November 20, 2009

Pinchin File No. 02-03-00077

**Re: St Bernard's Elementary School, Witless Bay, NL
Follow-Up Mould Investigation**

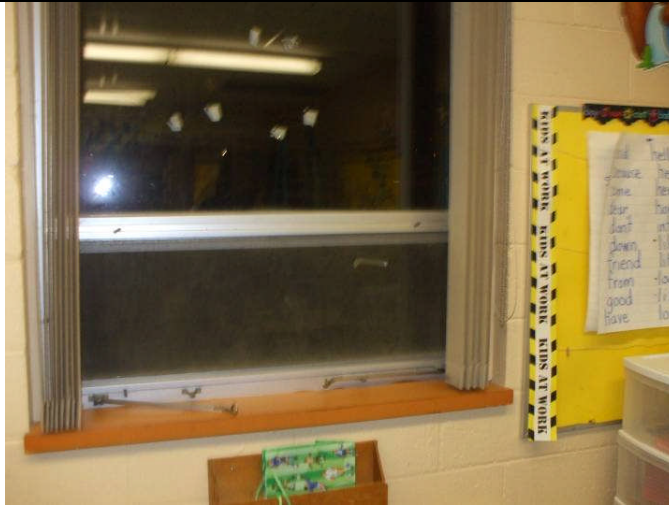
Visible dust was noted on window screens in Room 109 and on tennis balls used for cushion supports on the legs of chairs (Photos 1 and 2). Removal of the rubber baseboard from the only drywall wall in the room did not reveal visible mould growth on this material or the drywall wall. Moisture checks of the drywall wall did not detect any elevated building material moisture sources. Visual inspections of the interior of the wall looking down between the drywall walls of Rooms 109 and 107 from above the ceiling tiles also did not reveal any visible signs of mould growth (Photo 3). Visual inspections of the ceiling space revealed all metal products consisting of steel structural support beams, webbed joisting and a Q-decked metal roof (Photo 4).

PHOTO 1 – ROOM 109 – EXAMPLE OF WINDOW SCREEN WITH VISIBLE DUST.

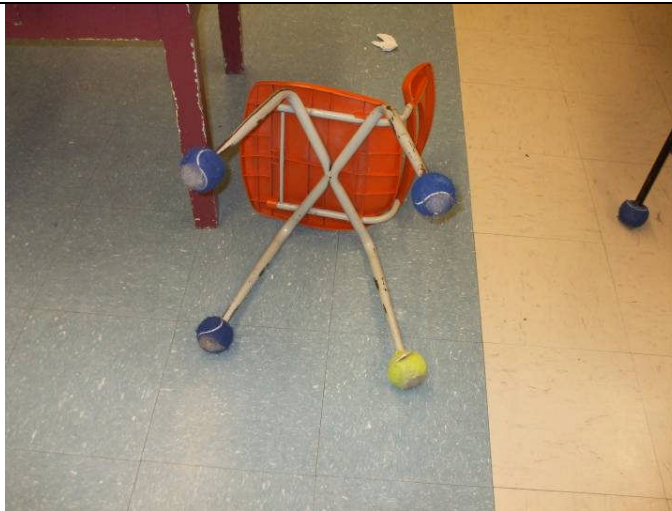
PHOTO 2 – ROOM 109 – EXAMPLE OF VISIBLE DUST BUILD UP ON TENNIS BALL CHAIR CUSHIONS.

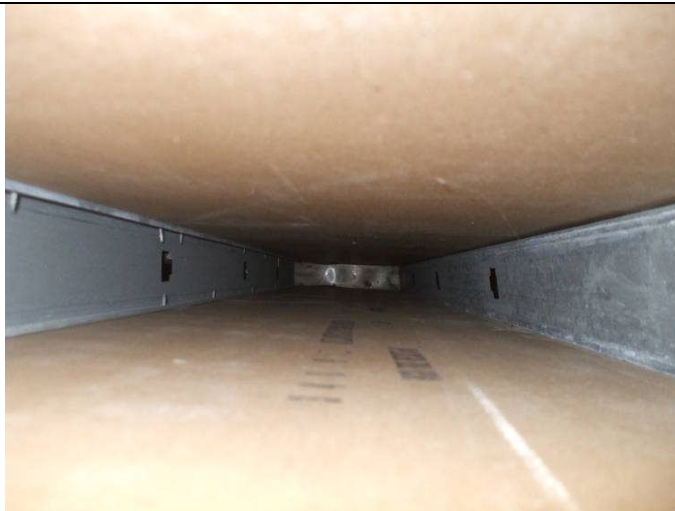
PHOTO 3 – AN EXAMPLE OF AN AREA OF DRYWALL WALL INSPECTION BETWEEN ROOMS 109 AND 107 – PHOTO TAKEN FROM ABOVE CEILING TILE LOOKING DOWN.

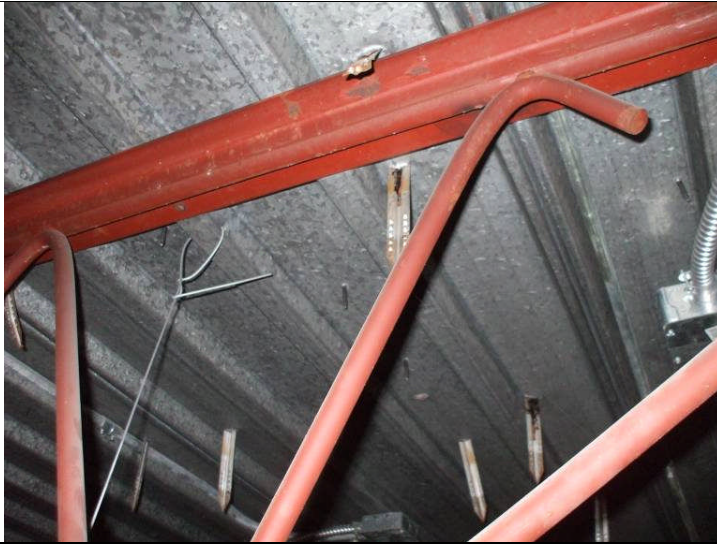
PHOTO 4 – EXAMPLE OF UPPER ROOFING MATERIAL.

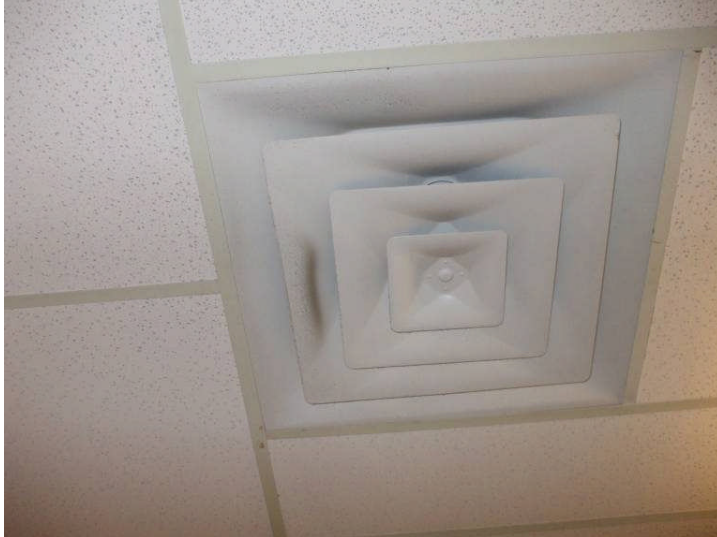
Visual inspection also observed slight to moderate dust build-up on some the air supply diffuser grilles associated with the building air handling unit. This may be an indicator of improper filters, filter fit, or dirt build-up within the ventilation ducts (Photo 5).

PHOTO 5 – EXAMPLE OF HVAC AIR SUPPLY DIFFUSER SHOWING DUST BUILD UP.

- Existing filters associated with the buildings air exchange system be inspected to see if they are properly fitted into the filter casing or are worn and are causing a breakdown of

filtration. Inspections should also be made into the ductwork for the presence of dust build-up. Dust observed on the air supply diffuser grills and inside air ventilation ducts should be cleaned.
