**INDOOR AIR QUALITY ASSESSMENT
ST. BERNARDS ELEMENTARY SCHOOL
WITLESS BAY, NL**

**EASTERN SCHOOL DISTRICT
215 WATER STREET
ST. JOHN'S, NL
A1C 6C9**

November 17, 2009

Pinchin LeBlanc Environmental Project: 02-03-00077

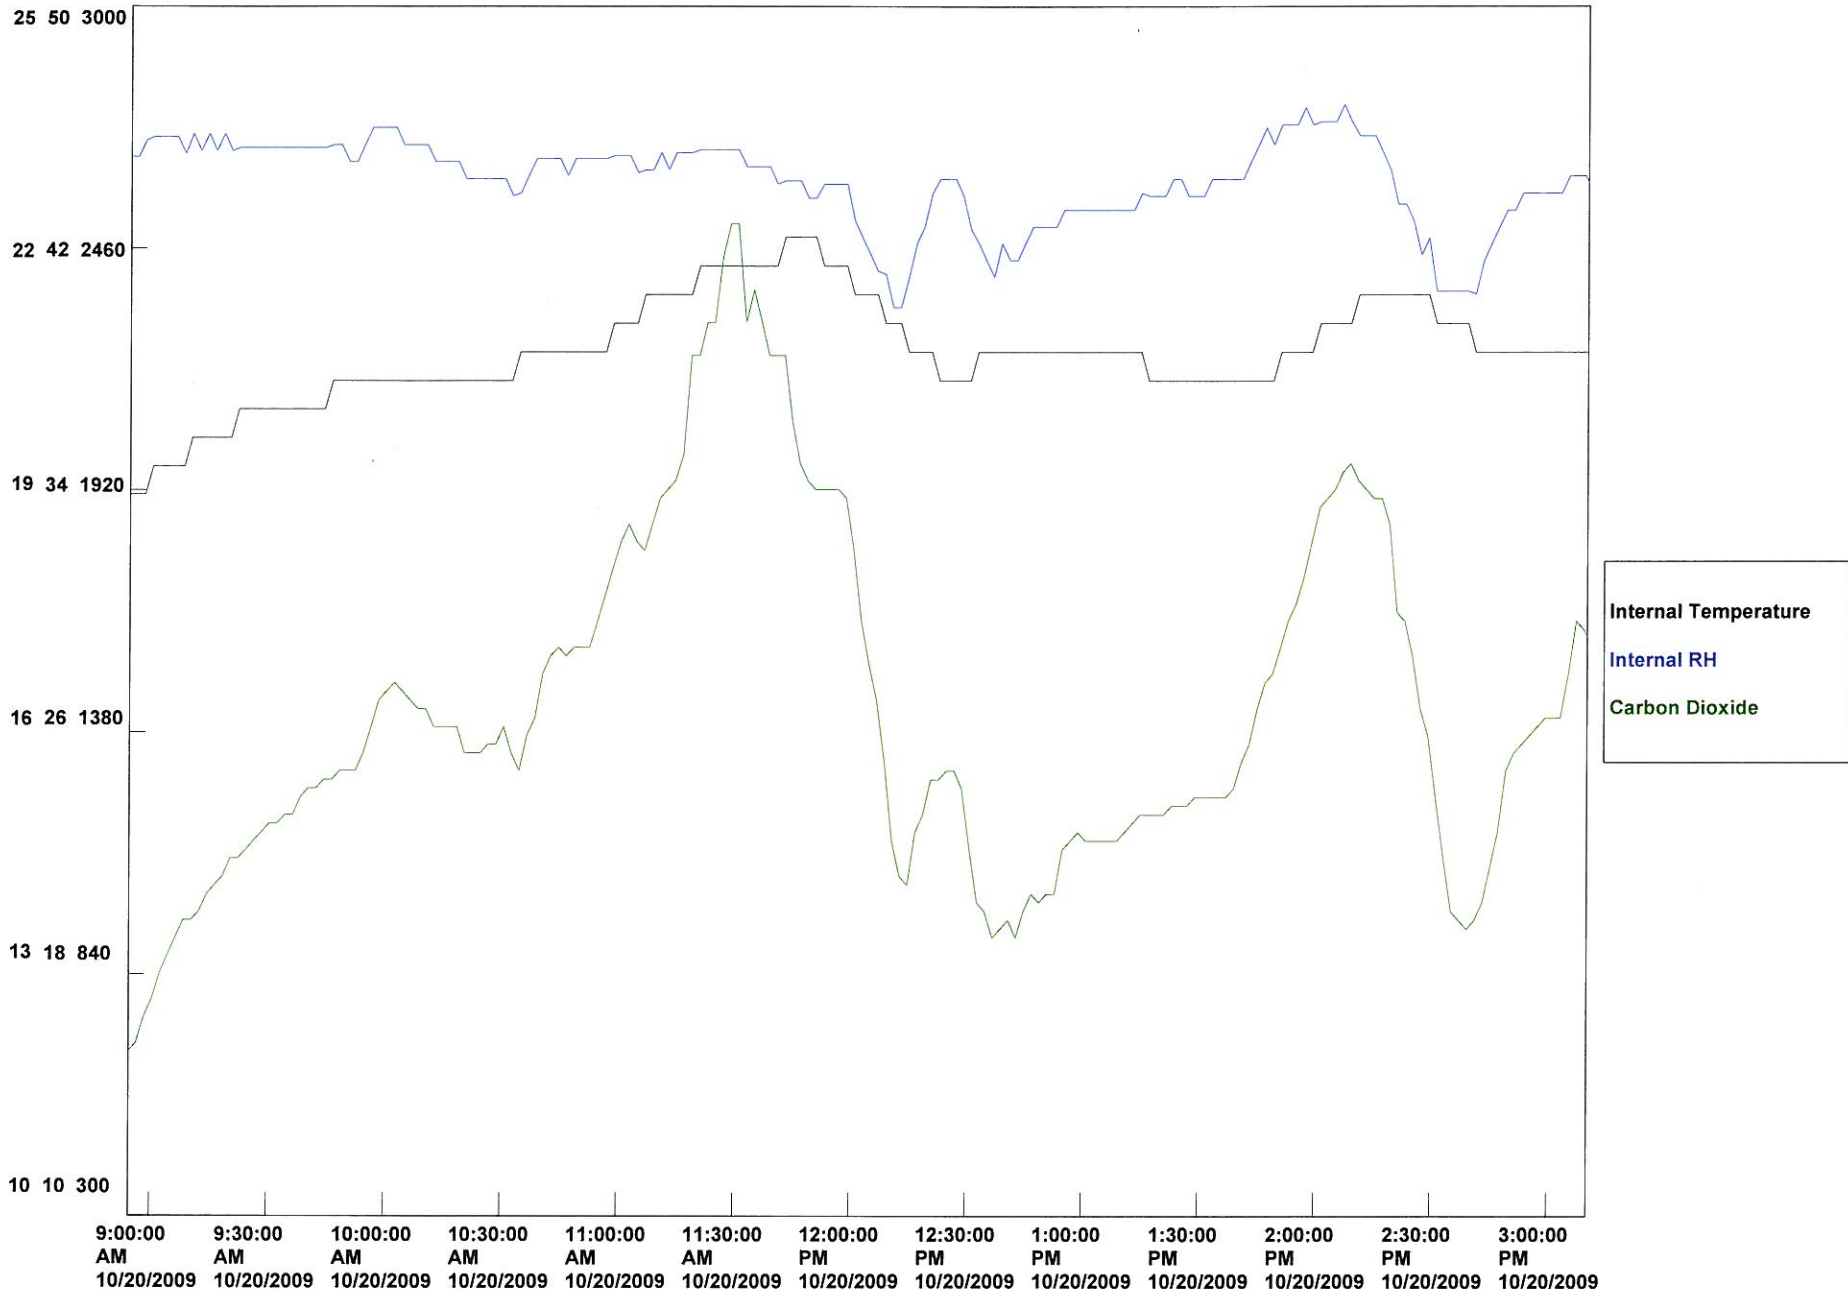
St. Bernards Elementary School - Room 132 - DAY 1

The average level of carbon dioxide (1430ppm) recorded on Day 1 exceeded the recommended site specific comfort range of 1105ppm.

The average level of temperature (20.7 °C) recorded on Day 1 was within the recommended temperature comfort range of 19.5 to 25 °C.

Continuous Monitoring
Carbon Dioxide, Temperature & Relative Humidity
Room 132 - Day 1 - October 20, 2009
9:00 AM – 3:00 PM

Parameter	Low	High	Average
Carbon Dioxide (ppm)	667	2515	1430
Temperature (° C)	18.9	22.1	20.7
Relative Humidity (%)	40.1	46.8	44.2

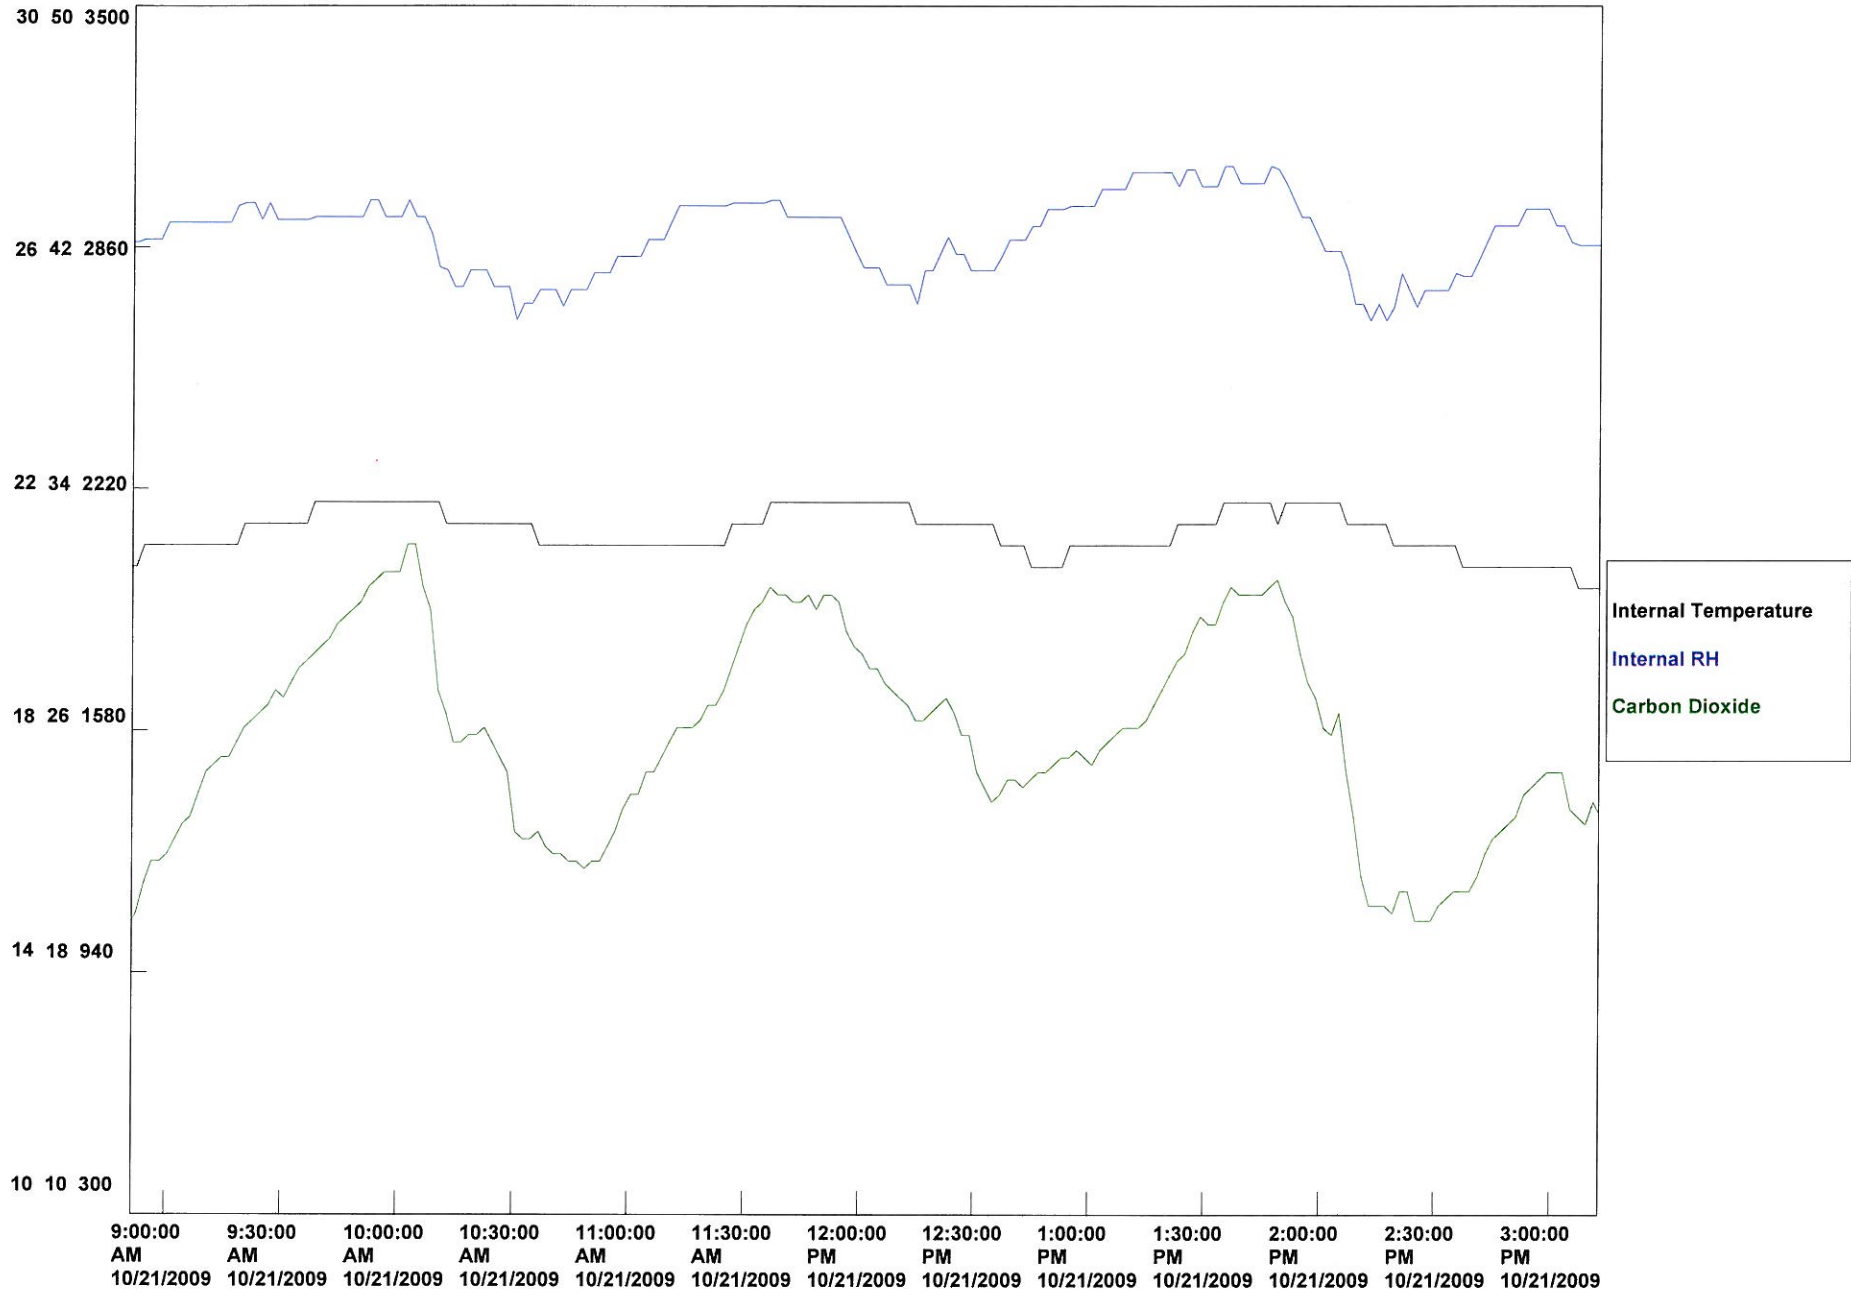
St. Bernards Elementary School - Room 132 - DAY 2

The average level of carbon dioxide (1570ppm) recorded on Day 2 exceeded the recommended site specific comfort range of 1101ppm.

The average level of temperature (21.3 °C) recorded on Day 2 was within the recommended temperature comfort range of 19.5 to 25 °C.

Continuous Monitoring
Carbon Dioxide, Temperature & Relative Humidity
Room 132 - Day 2 - October 21, 2009
9:00 AM – 3:00 PM

Parameter	Low	High	Average
Carbon Dioxide (ppm)	1078	2074	1570
Temperature (° C)	20.4	21.8	21.3
Relative Humidity (%)	39.6	44.7	42.4

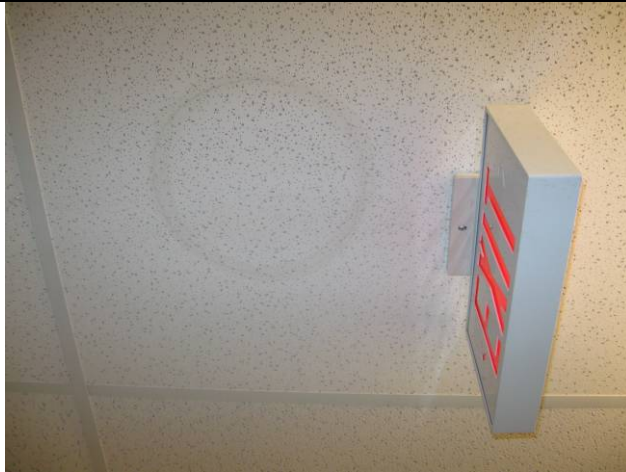
moisture sources were detected on the days of the assessment. One (1) stained ceiling tile was noted next to the Exit Sign in the Hallway located at the center entrance to the school (Photo 1).

PHOTO 1 – STAINED CEILING TILE – HALLWAY BY CENTER ENTRANCE TO SCHOOL.

Recommendation: The water stained ceiling tile should be replaced from next to the exit sign in the hallway located at the centre entrance to the school and the source of the water infiltration investigated and corrected.
